2006 – 2008 CHEVROLET IMPALA, IMPALA SS TECHNICAL SERVICE BULLETIN

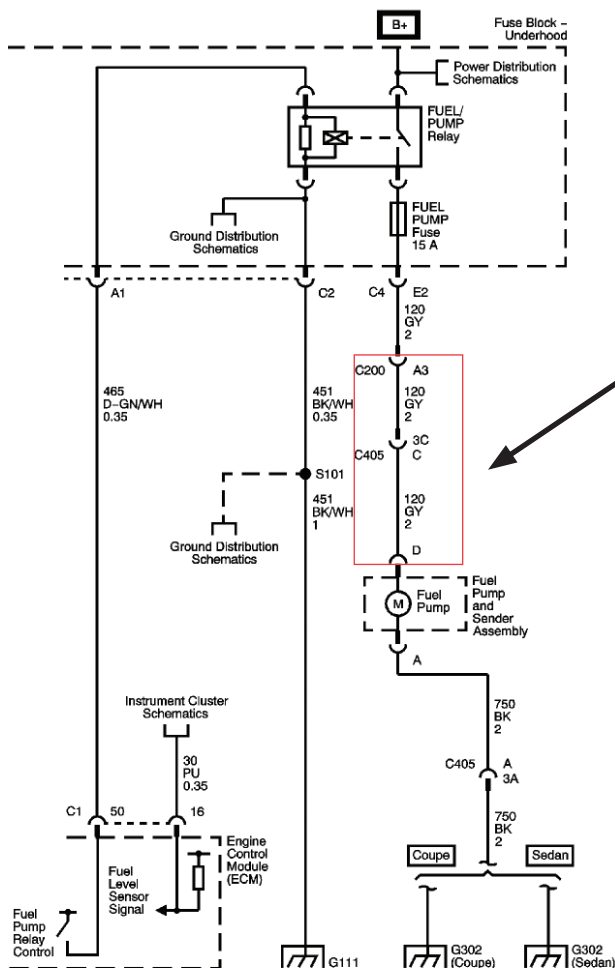
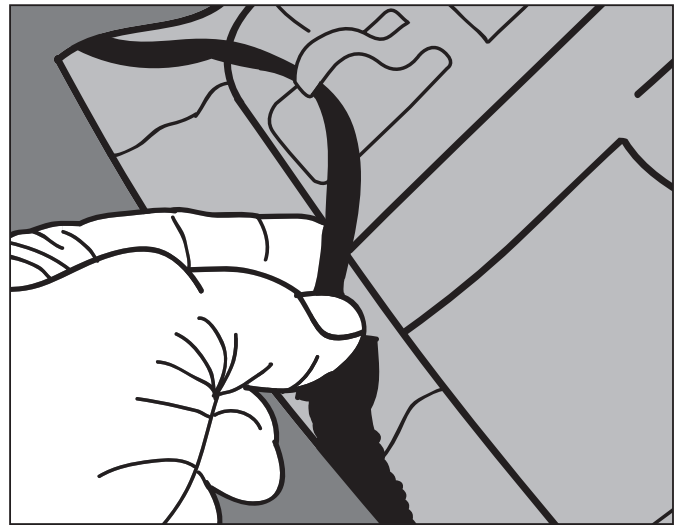
Some vehicles may have a no start condition & have no fuel pressure. This could be diagnosed incorrectly as a fuel pump failure. There is a known issue with the wiring harness rubbing the undercarriage. This can damage the wire resulting in a blown fuse. This can lead to an unnecessary fuel pump replacement. Before replacing the fuel pump you will need to check for power at the fuel pump connector.

The wiring harness that is affected is located under the rear seat. Remove the seat & inspect the grey wire, circuit 120 between connectors C200 & C405. If wire damaged is found, reroute the wiring harness away from this area. Repair the wiring & replace fuse. Recheck power to the fuel pump & fuel pressure. If power & pressure are within specs reinstall rear seat.
