Dodge Dakota Fuel Pump Positioning/ Alignment Technical Service Bulletin

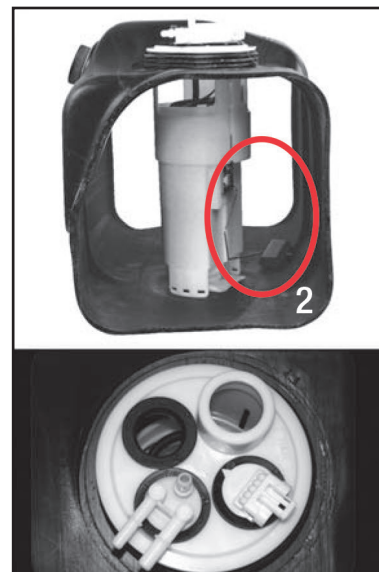
Because of the narrow fuel tank design on Dodge Dakota pickups (1991-96), fuel pump replacement requires precise positioning of the fuel pump module assembly. Improper positioning results in inaccurate fuel-level readings due to obstruction of the fuel-level sending unit float within the tank. Failure to properly align the new pump and installing with even a small amount of offset from the original factory position can lead to binding of the float arm on the fuel tank sidewall.

The fuel pump module assembly, when improperly aligned, causes interference between the fuel-level sending unit float and fuel tank sidewall (oval 2).

**Improperly positioned fuel
pump module assembly**

The Airtex E7050M fuel pump module assembly is marked with an alignment arrow to ensure proper positioning. However, in many cases it may be difficult to see the corresponding alignment indicator on the original fuel tank due to dirt, road grime, or tank position when installing the new assembly. If this is the case, refer to the guidelines listed in this document to ensure proper fuel pump module assembly alignment and accurate fuel-level readings.

Ensure that tank alignment indicator is properly positioned relative to the fuel pump module assembly alignment indicator (top photo detail). If alignment indicators are not visible due to contamination or fuel tank position, ensure that pump is positioned per the reference marks relative to the front and rear of the vehicle.
